FIRE IN U.S. ARMY HELICOPTER ACCIDENTS

1 JULY 1957 THROUGH 30 JUNE 1965

By
Emil Spezia

Report No. HF 67-1

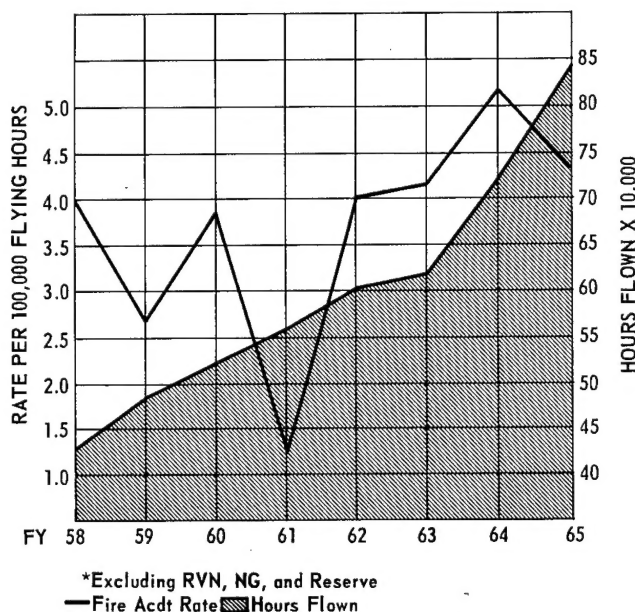
FIGURE 1

FREQUENCY AND NUMBER OF FIRE ACCIDENTS: Over the eight years of this report, the fire accident rate has varied from a low of 1.25/100,000 flying hours in FY 61 to a high of 5.2/100,000 hours in FY 64 (see Figure 1). The annual mean rate for the period is 3.7/100,000 flying hours. The rates of Figure 1 include the occurrence of fire in the classifications of accidents listed in Table 1. Note, however, that the rates of Figure 1 do not include 55 fire accidents listed in Table 1 as accountable to the National Guard, Army Reserve, and Vietnam operations.

It is clear in Figure 1, other than the abrupt drop in FY 61, that the increase in fire accidents tends to follow the increase in flying hours. Such a pattern was indicated in the data of earlier reports. There appears to be more than one reason for the

Helicopter Fire Accidents*
Rate vs Hours Flown
July 1957 - June 1965

parallel pattern. One apparent reason, as shown in Figure 1, is the correlation of exposure. With the increase of flying hours, the fire accident rate can also be expected to increase. Another reason which complements the first is the fact that essentially the same inventory of helicopters has been in use throughout the period. The inventory has increased in total number, new series have been added to old models, and even two new models, the UH-1 and CH-47, have been added, but nothing has changed in terms of making these models more crash-fire-worthy. The addition of the UH-1D and CH-47 late in the period has had no apparent effect on the fire accident pattern. Neither of these models, though the UH-1 has earned a comparatively good fire accident record, incorporate any major advances in crash-fire-worthiness design.
